BALLISTICALLY TOLERANT ROTOR BLADE INVESTIGATION

Edward T. Keast

Boeing Vertol Company

April 1975

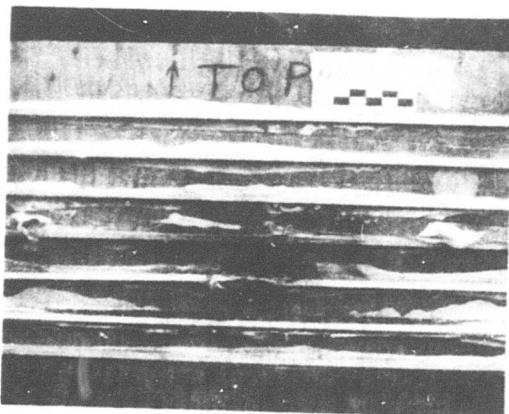
Figure 5. 20mm HEI Hits on Plywood Panel Reinforced With 7/16-Inch Square Fiberglass Load Paths.

Prior to this investigation, ballistic tests had been conducted jointly by Boeing and the Army Ballistic Research Laboratories to determine the probability of survival of fiberglass load paths. In these tests, the upper and lower surfaces of the rotor blade spars were simulated by plywood sheets. Strips of fiberglass sections 7/16 inch square were bonded to these sheets (Figures 4 and 5). They were impacted with 20mm HEI M56E2 rounds. The probability of such load paths surviving is dependent on the density of the shrapnel patterns, the mass of the individual fragments, and their velocities. The tests indicated about 50 percent chance of these 7/16-inch x 7/16-inch strips surviving 20mm HEI when in the shrapnel cone. Probability of survival against 23mm HEI is somewhat less due to the more potent shrapnel. Strips of larger cross sections would, of course, have a higher probability of survival. Strips of 1/2 inch by 1/2 inch may be expected to have a 50 percent chance of survival against 23mm HEI. This type and size strip was used in two of the concepts selected for these tests: Designs 2 and 3.

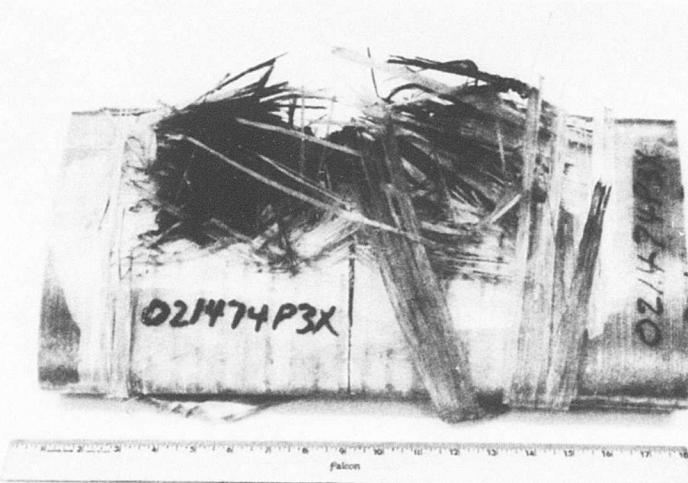
Figure 45. Photographs of Hit Number 021474P3 - Test 3
(Photographed After Cutting Section).

Figure 44. Damage Due to Hit Number 021474P3 - Test 3,
Design 6A.
